POST INSTALLATION ANALYSIS OF CHP PROJECTS

Rafael M. Negrón, Principal
Norgen Consulting Group, Inc.

The presentation will show how actual data and utility metering data collected after the installation of a 150 kW CHP in a NYC multifamily building was used to optimize system performance of radiator fans, circulating pumps and existing DHW equipment. The presentation will also show how logger data was used to identify problems with system components that may limit the potential savings to the client. Finally, it will show how post installation monitoring helped establish the optimal seasonal operating hours for the system that maximized thermal energy consumption and minimized unwanted heat dumping.

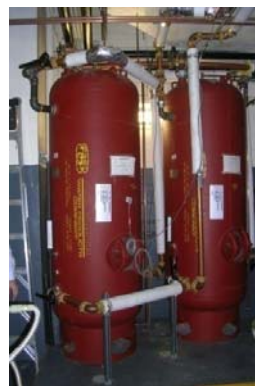
The new hot water storage tanks have built in water temperature sensors. However, these are analog sensors and logging the data was not possible. Temperature sensors were attached to the supply and return lines into and out of the tanks. The sensors were covered with insulation and the readings were calibrated against the internal temperatures. Data loggers were used to record the temperatures as above. One set of storage tanks is shown in Figure 3.

Figure 3 DHW STORAGE TANKS

- The flow to each set of hot water storage tanks was adjusted to keep them balanced and optimize thermal transfer.
- NCG recommended that the system not operate from 12 midnight to 5 a.m., especially in the summer period. However, since it is not clear how many BTUs are being dumped during this period, it is hard to quantify the economic impact to the project. The thermal dumping may be negligible to the value of the electricity offset.

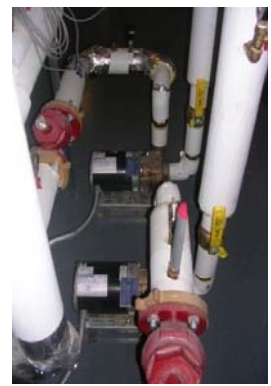
The operation of the hot water circulating pumps was measured using current transformers (CTs) attached to the conduits in the shut-off switch. In this case, the amperage values were less important than establishing when the pumps were operational. Data logging intervals were established to coordinate with the other loggers to compare the readings against other parameters such as CHP supply temperatures or storage tank return water temperatures. The hot water pumps are shown in Figure 4.

Figure 4 CIRCULATING PUMPS

- The thermostat on the circulating pump was changed and the activation temperature changed. This is a strap-on thermostat which is subject to a high error bandwidth and calibration errors. If the CHP can be made to reach 190 °F, these thermostats will have to be changed in order to ensure the hot water storage tanks do not exceed 180 °F.

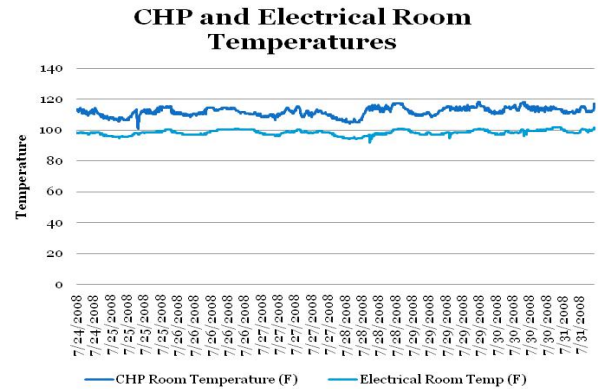
The CHP room temperature was found to be, on average, 115 °F and fairly stable. This appears to be in the acceptable operating range for the CHP. The electrical room temperature was found to be in the mid to high 90’s. This temperature was not much higher than the typical room temperature prior to the start of the CHP. The data is shown graphically below in Figure 5. Since the readings represented a worst case scenario finding, no further action was required.

Figure 5 CHP & ELECTRICAL ROOM TEMPERATURES

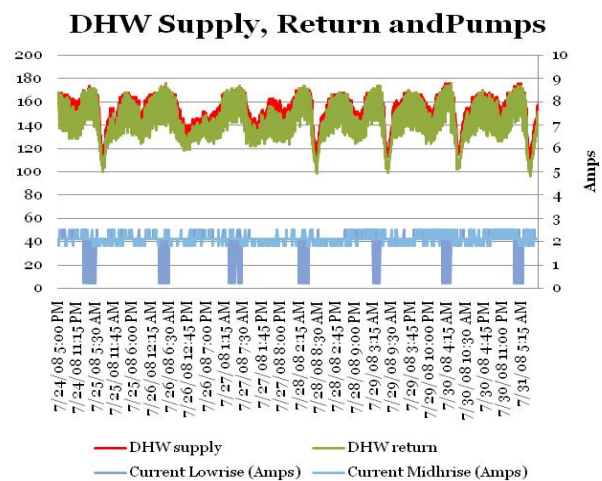
A representative graph of the data collected on the DHW storage tanks, the CHP supply temperature and the circulating pumps is shown below in Figure 6.

Figure 6 DHW Storage and Circulating Pumps

Analysis of the data collected along with the CHP supply and return readings suggested the following:

- The data showed that there are two (2) points of “peak” hot water usage; once in the morning and another (smaller) peak at night.
- The storage tanks “equalize” twice a day. This is when the temperature of the water in to the tank is the same as the temperature coming out of the tank. The first time is in the early afternoon and the second time is in the early morning hours (12 a.m. to 5 a.m.).
- The CHP supply water temperature never reached the 190 °F temperature as specified by the CHP provider. This can be seen on the graph when the

temperatures in to and out of the tanks were at their highest point and did not exceed 180 °F.

- One of the thermostats on the circulating pumps was either not working or was not configured correctly. This would be a problem if the supply temperature exceeds 180 °F which represents the maximum allowable temperature in the tank.

- The domestic hot water heaters inlet trigger temperature was lowered from 165 °F to 155 °F in order to minimize their firing. This adjustment had no impact to resident comfort.

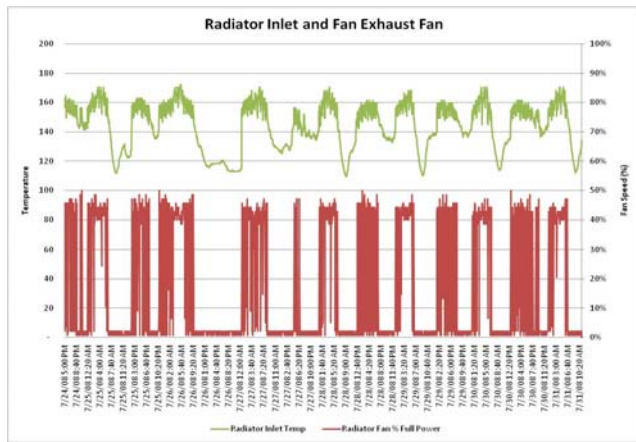
The data collected from the loggers installed on the radiator fan motor disconnect and radiator inlet temperature (as well as the other data collected throughout the system) suggested that dumping was happening more frequently than expected. Some of the data is shown graphically below in Figure 7.

Figure 7 RADIATOR LOGGER DATA

The data showed a clear correlation between the point of equalization in the domestic hot water tanks and thermal dumping in the radiator, as expected. However, the amount of dumping, as seen by the level of fan operation appeared to be much higher than expected, especially during the afternoon. Finally, the data showed that dumping was occurring even though the CHP supply temperature did not reach the 190 °F specified in the literature. A 24 hour sample of the data is shown graphically in Figure 8.

- In order to minimize the thermal dumping, the bandwidth on the VFD was expanded to allow for greater variability in fan operation. In addition, the trigger temperature was increased to 160 °F in order to limit fan operation during nominal bypass events. These adjustments significantly reduced the incidence of radiator operation as can be seen Figure 9. However, it is evident that there will be dumping even in the winter in spite of using the system to heat the pool during this time.

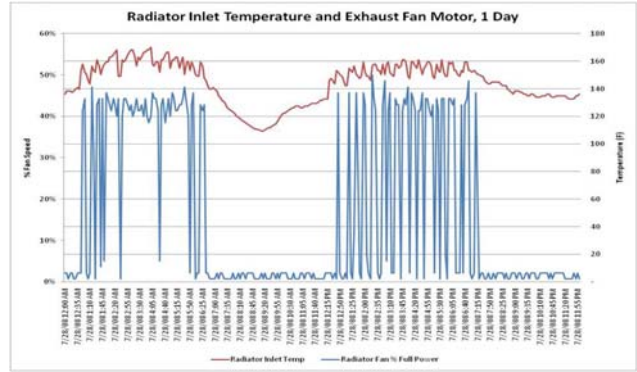
Figure 8 TWENTY FOUR HOUR RADIATOR DATA

The thermal dumping at night was much steadier than that during the day. The data confirmed our initial study conclusion that the machine should not run at night.

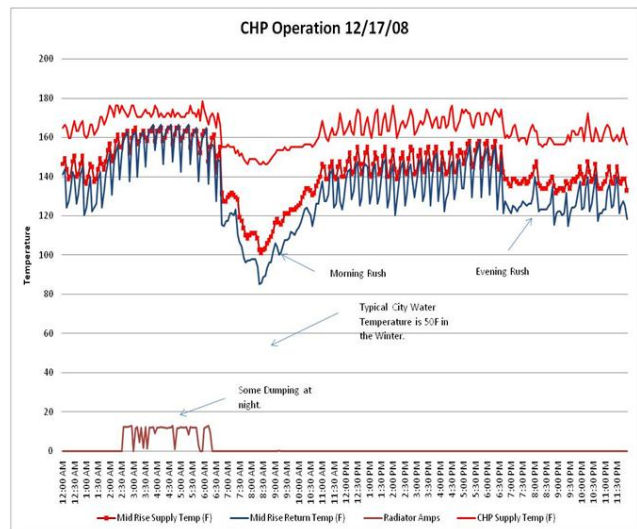
Figure 9 POST ADJUSTMENT RADIATOR OPERATION
